Aircraft loading and in-flight controllability issue involving Fairchild SA227, VH-HPE

Rockhampton Airport, Queensland, on 11 May 2020

ATSB Transport Safety Report

AO-2020-027

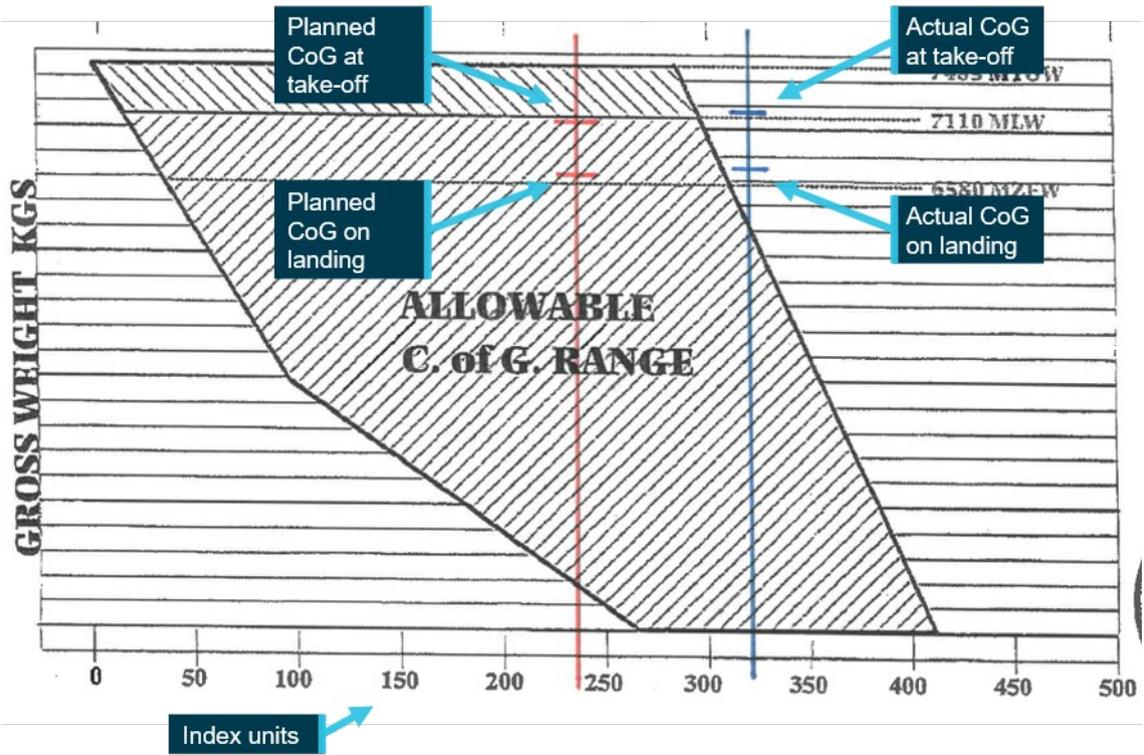
Appendix C – Centre of gravity (CoG) position (Rockhampton to Brisbane)

The pilot subsequently completed a new load and trim sheet using the actual weights and the centre of gravity was found to be aft of the rear limit (outside of the limits) (Appendix C).

Compartment	Load plan (kg)	Actual weights (kg)	Weight difference (kg)
Nose	126	65	-61
1	527	545	+18
2	582	606	+24
3	411	475	+64
4	219	225	+6
5	90	103	+13

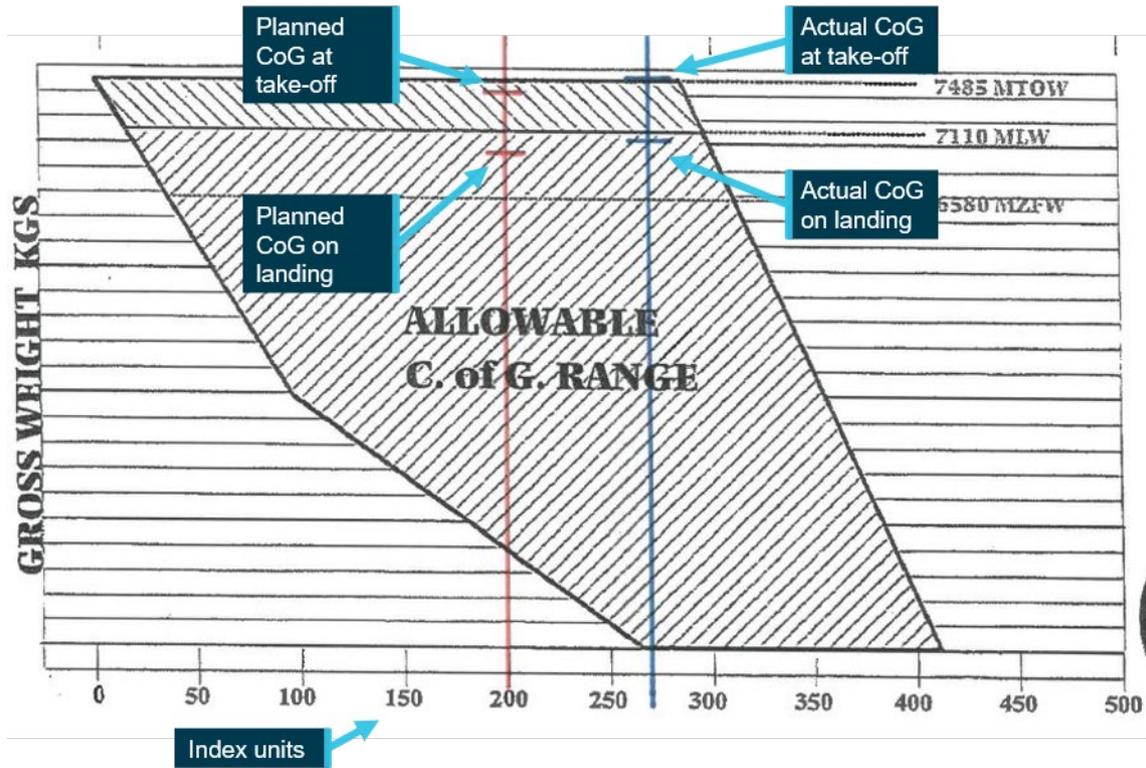
Appendix D – Centre of gravity (CoG) position (Townsville to Rockhampton)

A load and trim sheet with the actual weights determined that the load from Townsville was still within limits but the centre of gravity was much further aft than originally calculated. The recalculated load and trim sheet also revealed that the aircraft departed Townsville about 6 kg above its maximum take-off weight (Appendix D). A lower fuel load on departure from Rockhampton meant that the aircraft was within the take-off weight limits. However, the additional freight loaded in Rockhampton shifted the centre of gravity position beyond the rear limit.

Compartment	Original load plan (kg)	Revised load plan (kg)	Actual weights (kg)
Nose	0	126	65
1	527	527	545
2	582	582	606
3	426	300	364
4	219	219	225
5	87	87	100
