Air Accident Investigation Sector

- Final Report -

AAIS Case # AIFN/0006/2014

Aircraft Tail-Tipping

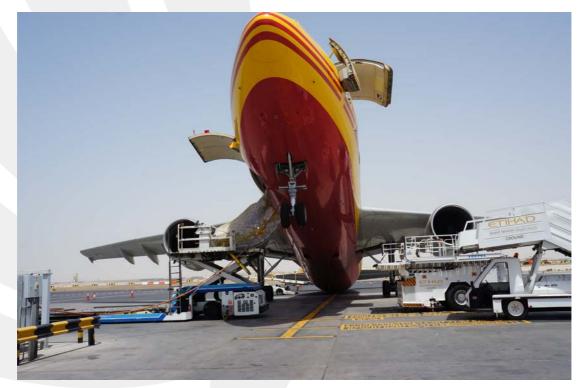
The Aircraft was loaded with a total of thirty cargo containers and pallets, of which ten containers and pallets were scheduled to be unloaded at Abu Dhabi. At 1348, while unloading the last pallet, the Aircraft tipped onto its tail, as shown in Figure 1.

Figure 1. Aircraft Tail-Tipping

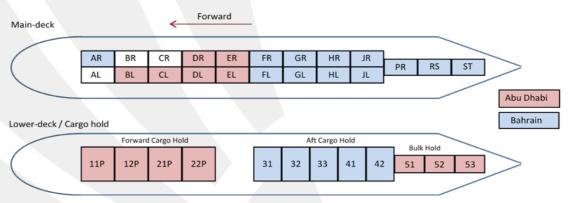
The cargo to be unloaded at Abu Dhabi consisted of six ULDs on the upper main-deck and four pallets in the forward cargo hold (forward lower-deck compartment), whereas all ULDs in the aft cargo hold (aft lower-deck compartment) were transit ULDs (Figure 2).

Figure 2. ULDs for Abu Dhabi (Red) and Bahrain (Blue)

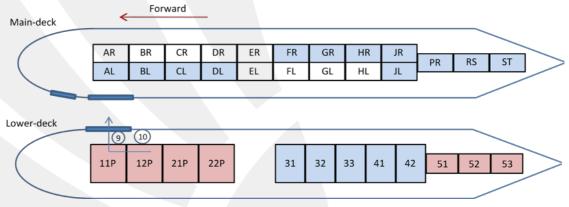
At 1330, the high loader operator at the forward cargo hold commenced unloading the two ULDs from positions 11P and 12P (Figure 7). The two loaders descended from the upper main-deck after moving four ULDs from positions BL through EL forward one position to positions AL through DL. The loaders then went to the forward cargo hold high loader to push the ULDs from the high holder onto the dollies.

Figure 7. Unloading ULDs on 11P and 12P

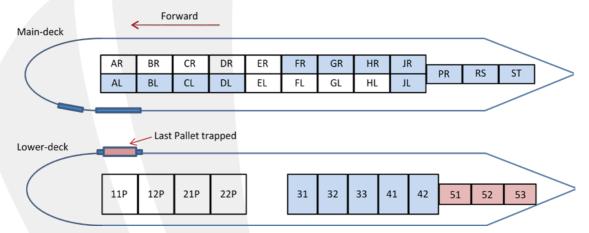
Figure 10. During unloading of the final pallet, the pallet net became snagged on the forward cargo hold door lock mechanism.

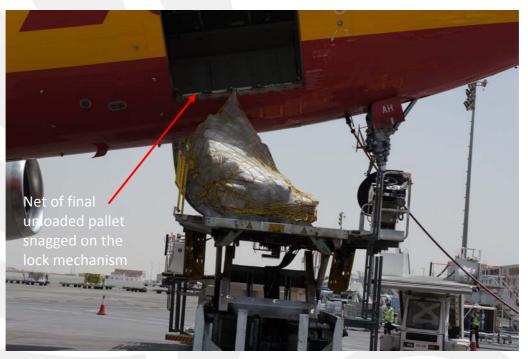
Figure 11. Net of the unloaded final pallet snagged on the lock mechanism of forward cargo hold door.

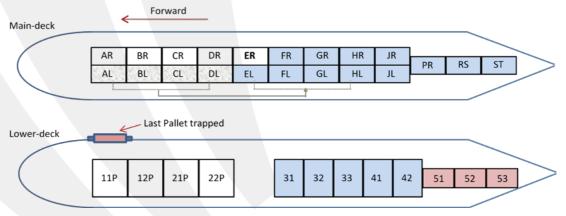
After the Aircraft's recovery, an inspection was carried out of the upper maindeck and it was found that the four ULDs on the left hand side (positions AL through DL), which had been repositioned, did not have the locks in the up position, and the bases of the third and fourth units (originally from positions CL and DL), were in an overlapping condition, which ended in positions GL and HL respectively, after the Aircraft had tipped onto its tail.

Figure 17. ULDs Configuration after Aircraft's Recovery

- 3.2.24 Damage to the conveyer belt (belt loader) was found due to the fact that it contacted the bulk hold door when the Incident occurred.
- 3.2.25 From the inspection after the Aircraft recovery, the four ULDs in positions AL through DL to balance the Aircraft were not locked into position, and the base of the third and fourth units (originally from positions CL and DL) were in an overlapping condition, which ended in positions GL and HL respectively. The other ULDs and FAKs were secured and their nets were in place.

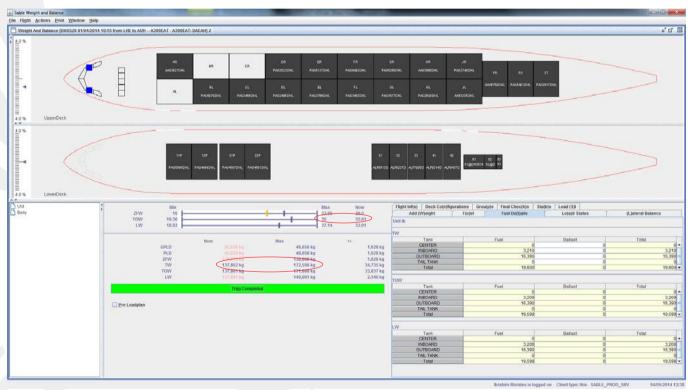
Figure A4-1 illustrates the SABLE weight and longitudinal balance (CG) simulation for the Aircraft' weight and CG position before unloading. The weight is 137,862 kg and the longitudinal CG position is at 32.01% Mean Aerodynamic Chord (MAC), whereas the maximum permissible aft CG position is at 35.0% MAC.

Figure A4-1. Simulated weight and balance of the Aircraft before unloading

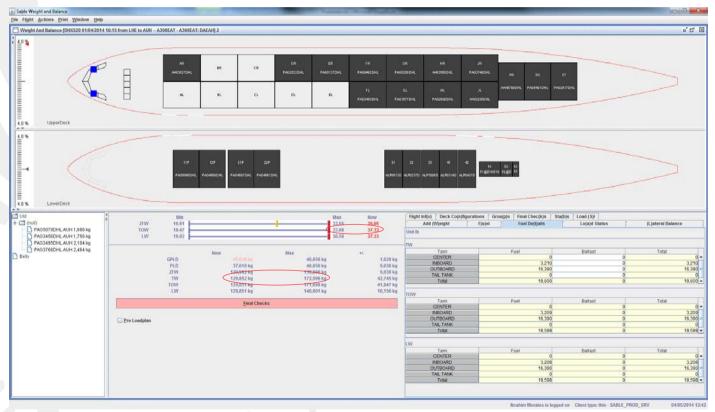
The simulation in Figure A4-2 illustrates the Aircraft weight and CG position after unloading the four ULDs in positions BL through EL on the maindeck. The weight is 129,852 kg and the longitudinal CG position is at 37.33% MAC, whereas the maximum permissible aft CG position is at 33.98% MAC.

Figure A4-2. Simulated weight and balance of the Aircraft after unloading ULDs in positions BL through EL

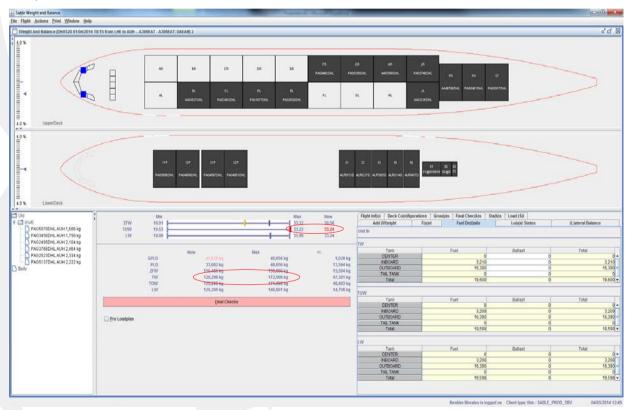
The simulation in Figure A4-3 illustrates the Aircraft weight and CG position after unloading the six ULDs on the main-deck intended for Abu Dhabi and four ULDs are placed in positions BL through EL. The weight is 125,296 kg and the longitudinal CG position is at 33.24% MAC, whereas the maximum permissible aft CG position is at 33.22% MAC.

Figure A4-3. Simulated weight and balance of the Aircraft after unloading six ULDs on the main-deck and placing four ULDs in positions BL through EL

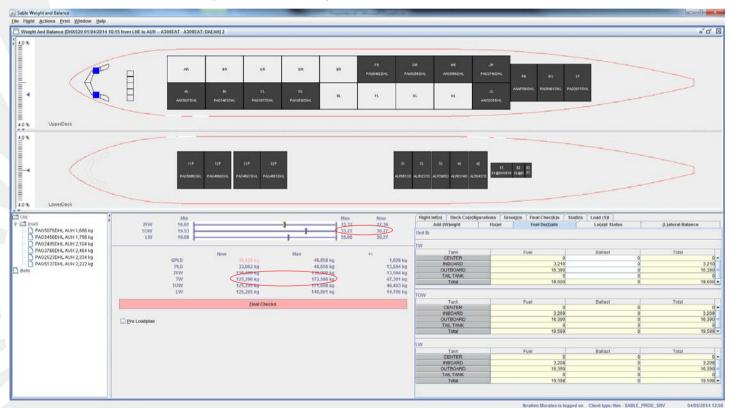
The simulation in Figure A4-4 illustrates the Aircraft weight and CG position after unloading the six ULDs on the main-deck intended for Abu Dhabi and four ULDs are moved from positions BL through EL to positions AL through DL, respectively. The weight is 125,296 kg and the longitudinal CG position is at 30.27% MAC, whereas the maximum permissible aft CG position is at 33.22% MAC.

Figure A4-4. Simulated weight and balance of the Aircraft after unloading six ULDs on the main-deck and placing four ULDs in positions AL through DL

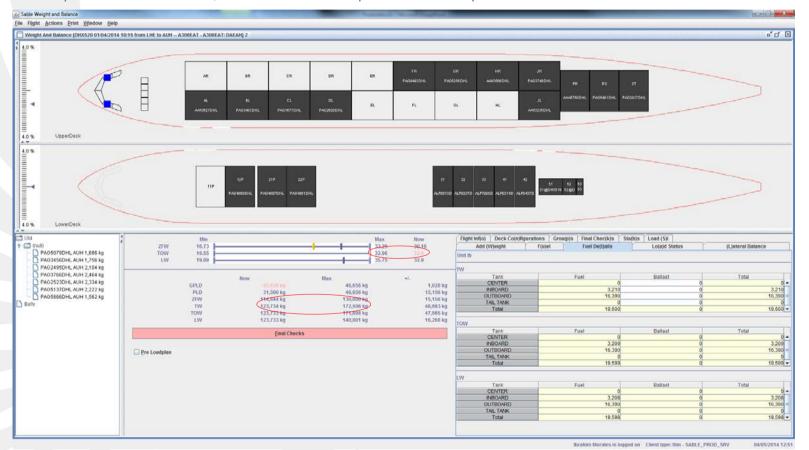
After unloading the first ULD, located in position 11P of the forward cargo hold, the Aircraft CG position was close to the maximum permissible aft limit. Unloading of the three ULDs in positions 12P, 21P and 22P, caused the CG position to move beyond the maximum permissible aft limit, and consequently, the Aircraft, started to pitch up.

Figure A4-5 illustrates simulation of the Aircraft weight and CG position after the ULD in position 11P is unloaded. The weight is 123,734 kg and the longitudinal CG position is at 32.9% MAC, whereas the maximum permissible aft CG position is at 32.96% MAC.

Figure A4-5. Simulated weight and balance of the Aircraft after unloading the 1st ULD in position 11P

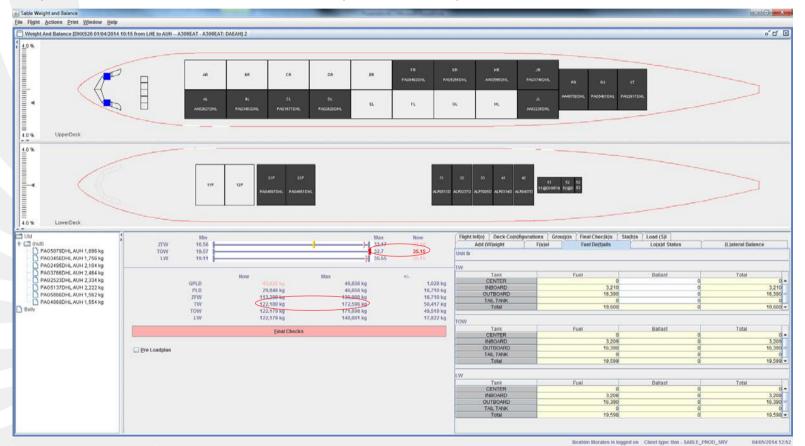
Figure A4-6 illustrates simulation of the Aircraft weight and CG position after ULD in position 12P is unloaded. The weight is 122,180 kg and the longitudinal CG position is at 35.15% MAC, whereas the maximum permissible aft CG position is at 32.7% MAC.

Figure A4-6. Simulated weight and balance of the Aircraft after unloading ULD in position 12P

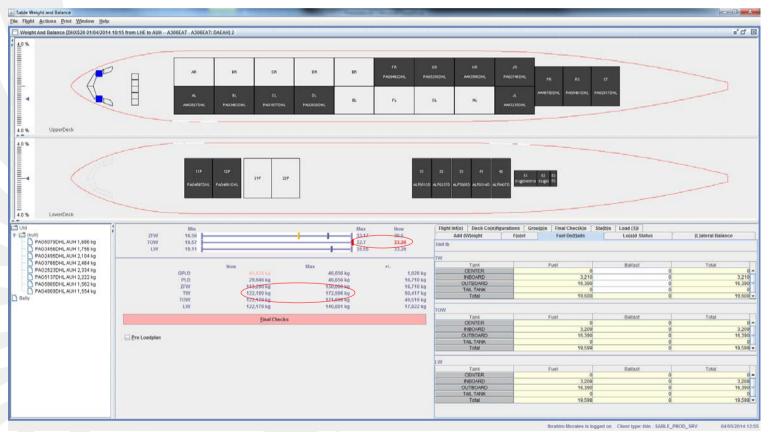
Figure A4-7 illustrates simulation of the Aircraft weight and CG position after ULDs in positions 21P and 22P are moved to positions 11P and 12P respectively. The weight is 122,180 kg and the longitudinal CG position is at 33.26% MAC, whereas the maximum permissible aft CG position is at 32.7% MAC.

Figure A4-7. Simulated weight and balance of the Aircraft after moving ULDs in positions 21P and 22P to positions 11P and 12P

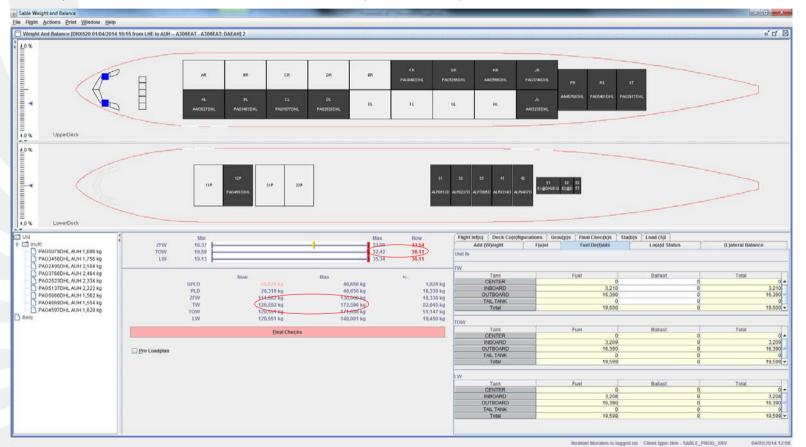
Figure A4-8 illustrates simulation of the Aircraft weight and CG position after the ULD in position 11P is unloaded. The weight is 120,552 kg and the longitudinal CG position is at 36.11% MAC, whereas the maximum permissible CG position is at 32.42% MAC.

Figure A4-8. Simulated weight and balance of the Aircraft after unloading the ULD in position 11P

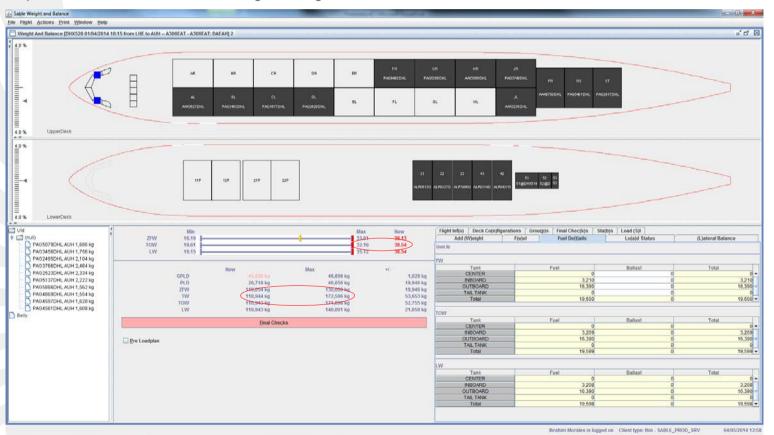
Figure A4-9 illustrates simulation of the Aircraft weight and CG position after the ULD in position 12P is unloaded. The weight is 118,944 kg and the longitudinal CG position is at 38.54% MAC, whereas the maximum permissible CG position is at 32.16% MAC. The weight and longitudinal CG of Figure A4-9 is representative of the actual condition as given in Figure 10.

Figure A4-9. Simulated weight and balance of the Aircraft after unloading the ULD in position 12P

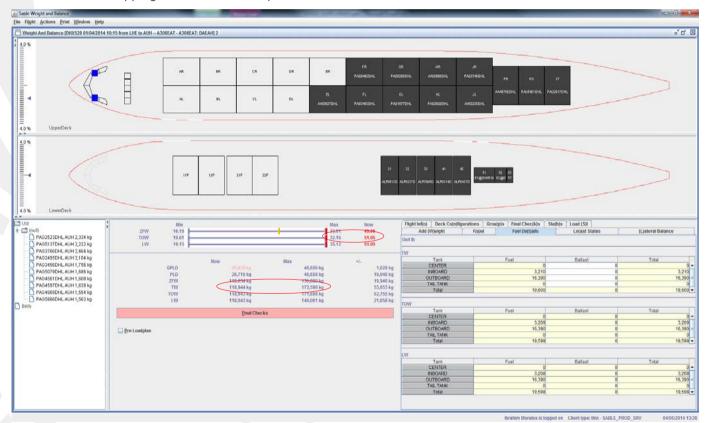
Alternatively, for unloading using the same unloading sequence as occurred during the Incident, but with the four ULDs in positions AL through DL, in the locked condition, the 38.54% MAC of CG position would not have led to tail tipping.

Figure A4-10 illustrates simulation of the Aircraft weight and CG position after the unlocked four ULDs in positions AL through DL moved/slipped to positions EL through HL. The weight is 118,944 kg and the longitudinal CG position is at 51.05% MAC, whereas the maximum permissible CG position is at 32.16% MAC. This means that slipping backwards each space of the four ULDs, the CG shifts aft about 3.12% MAC.

Figure A4-10. Simulated weight and balance of the Aircraft after 4 ULDs in positions AL through DL moved/slipped to positions EL through HL

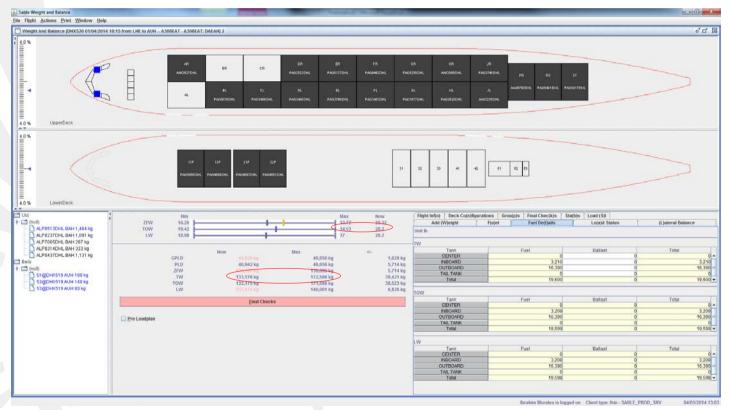
The simulation in Figure A4-11 illustrates the Aircraft weight and CG position if the unloading steps are commenced by unloading the aft cargo hold first, in accordance with the SOP. The weight is 133,176 kg and the longitudinal CG position is at 28.2% MAC, whereas the maximum permissible CG position is at 34.53% MAC.

Figure A4-11. Simulated weight and balance of the Aircraft when unloading starts from the aft lower-deck
