Collision during pushback between Boeing B737-8FE, VH-YID and Airbus A320-232, VH-VGR

Melbourne Airport, Victoria | 10 August 2013

ATSB Transport Safety Report
Aviation Occurrence Investigation
AO-2013-125
Final – 18 August 2016

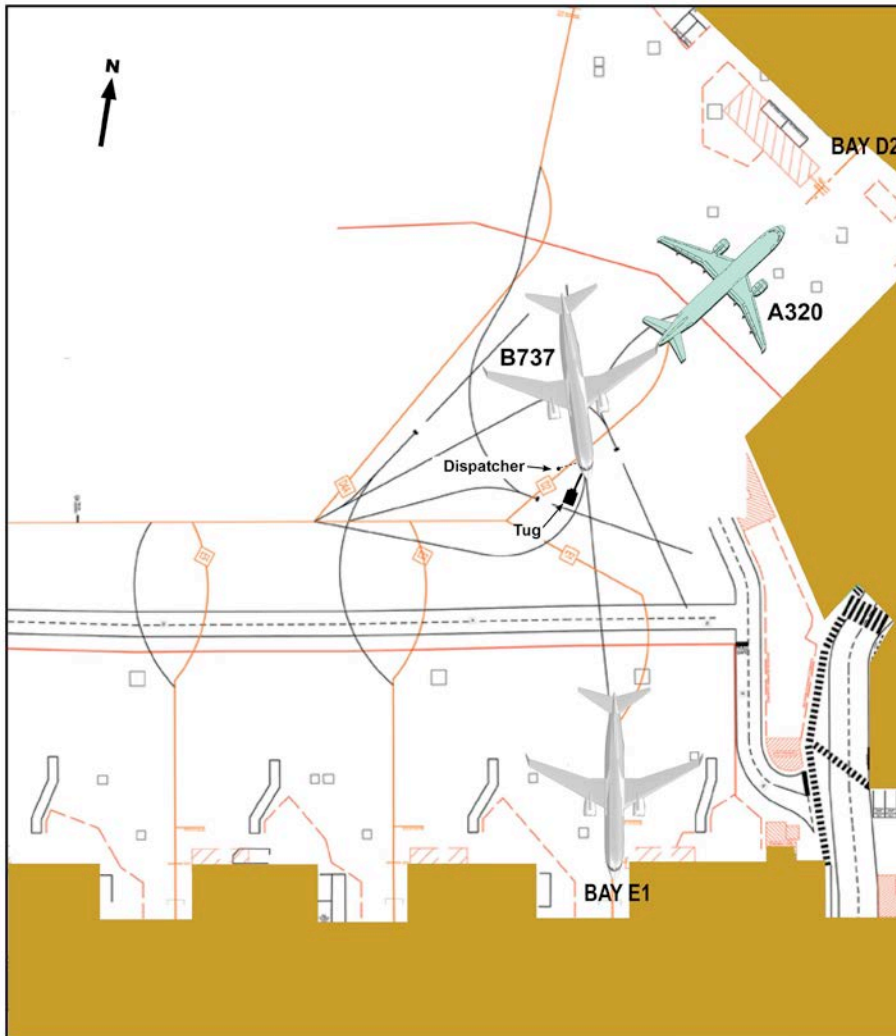
At 0930 Eastern Standard Time¹, VGR entered the apron en route to gate D2, when a Boeing B737-800, registered VH-YID (YID), requested pushback approval from gate E1 (Figure 1). YID was being operated by Virgin Australia Airlines Pty Ltd. on a flight to Maroochydore, Queensland. The controller advised the crew of YID that a Jetstar A320 was entering the apron behind them for bay D2 and that when that traffic was 'on the gate'², pushback from bay E1 was approved.

At 0933:03, the left wingtip of YID contacted the tail cone of VGR immediately aft of the operating auxiliary power unit. The tail cone of VGR immediately aft of the auxiliary power unit separated from the aircraft and fell to the ground. The left wingtip of YID was damaged during the collision.

Figure 1: Position of A320 VGR (in green), holding short of gate D2, and B737 YID (in grey) during pushback from Bay E1 at the time of the collision. The position of the dispatcher and tug for YID are also shown

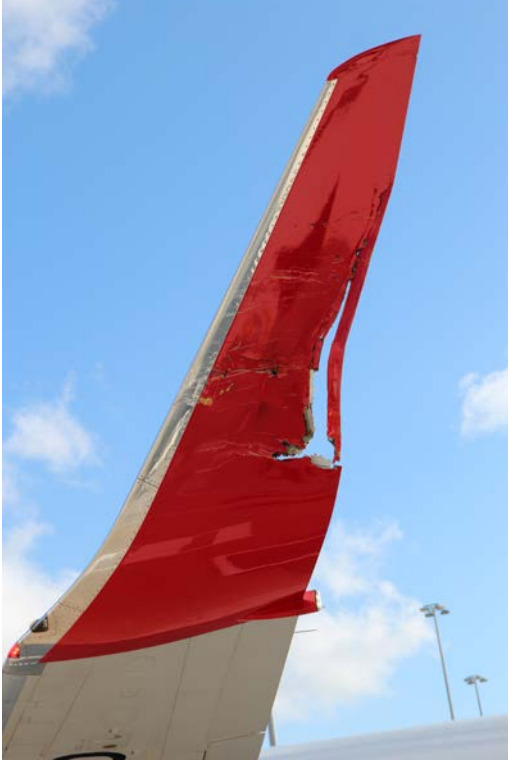
The left wingtip of YID was damaged during the collision (Figure 2).

Figure 2: Damage to the left wingtip of YID

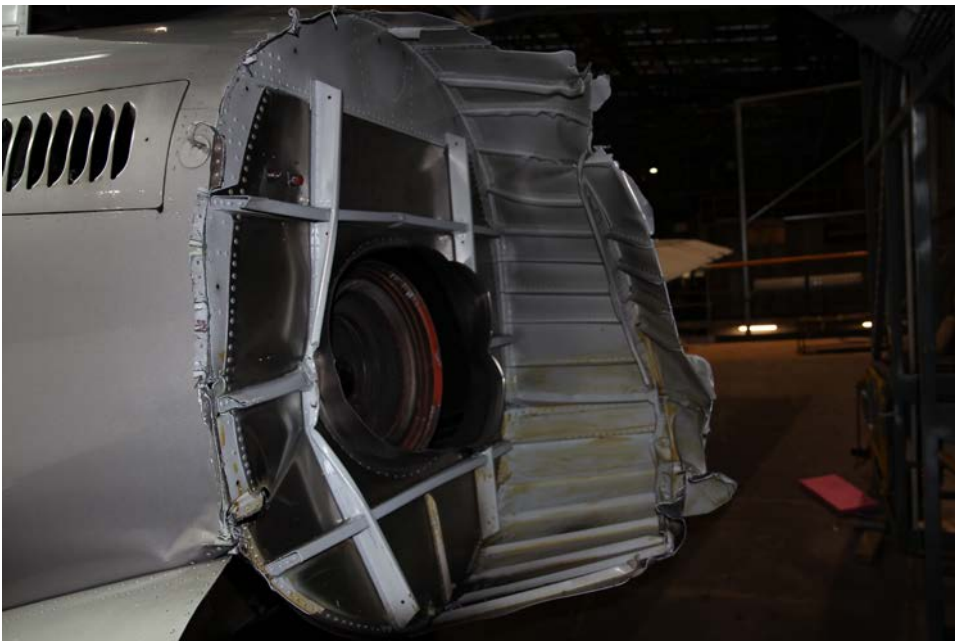
The tail cone of VGR aft of the auxiliary power unit (APU) and the APU exhaust duct separated from the aircraft (Figure 3). The bulkhead aft of the APU was buckled and there was also minor localised damage to the external skin.

Figure 3: Damage to the tail cone of VGR aft of the APU, looking from left to right of the aircraft

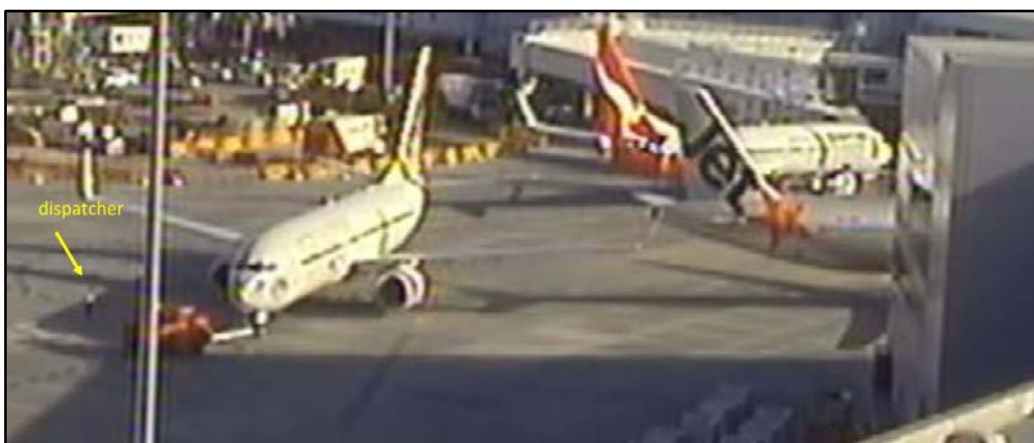
From the dispatcher's position to the front-right of YID on the day of the occurrence, it was not possible to see the left side of the aircraft during the pushback (Figure 4). During the ATSB's observation of operations at Bay E1 the following day, it was similarly noted that the dispatcher's position meant that the dispatcher could not see the left side of the aircraft (Figure 5).

Figure 4: Screenshot of YID during pushback, 5 seconds before the collision with VGR and showing the position of the tug and the dispatcher

- The dispatcher of the B737 could not visually confirm the position of the A320 relative to its assigned gate and incorrectly assessed that, as the aircraft was stationary, it was at the gate.
- The pushback of the B737 was commenced with insufficient clearance from the A320, which was not identified prior to the collision as the dispatcher's position to the right-front of the B737 prevented observation of its left wing.

Virgin advised that following this occurrence, they issued a local instruction to ground staff, mandating the use of wing walkers from certain bays at Melbourne Airport, including bay E1.

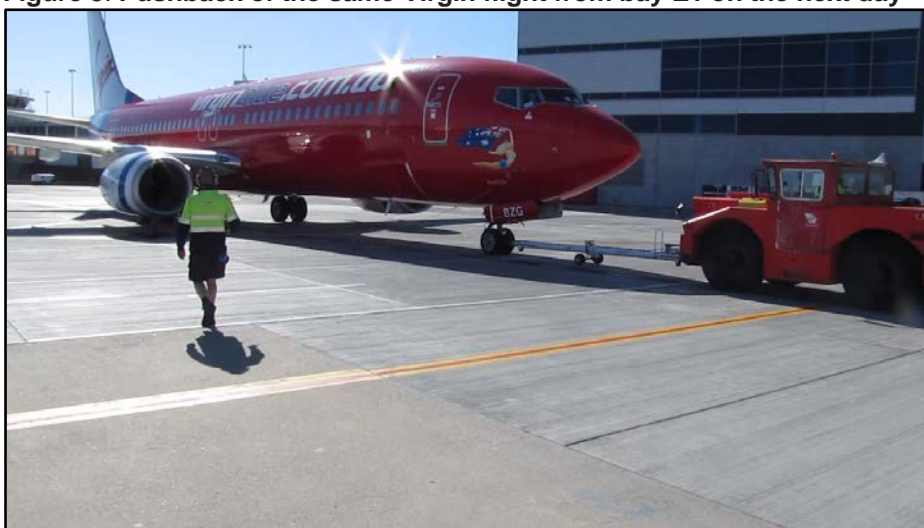
Figure 5: Pushback of the same Virgin flight from bay E1 on the next day
