# Collision with aerobridge involving Boeing 747-422, N119UA

Melbourne Airport, Victoria | 22 April 2013

Aviation Occurrence Investigation AO-2013-075 Final – 7 July 2016

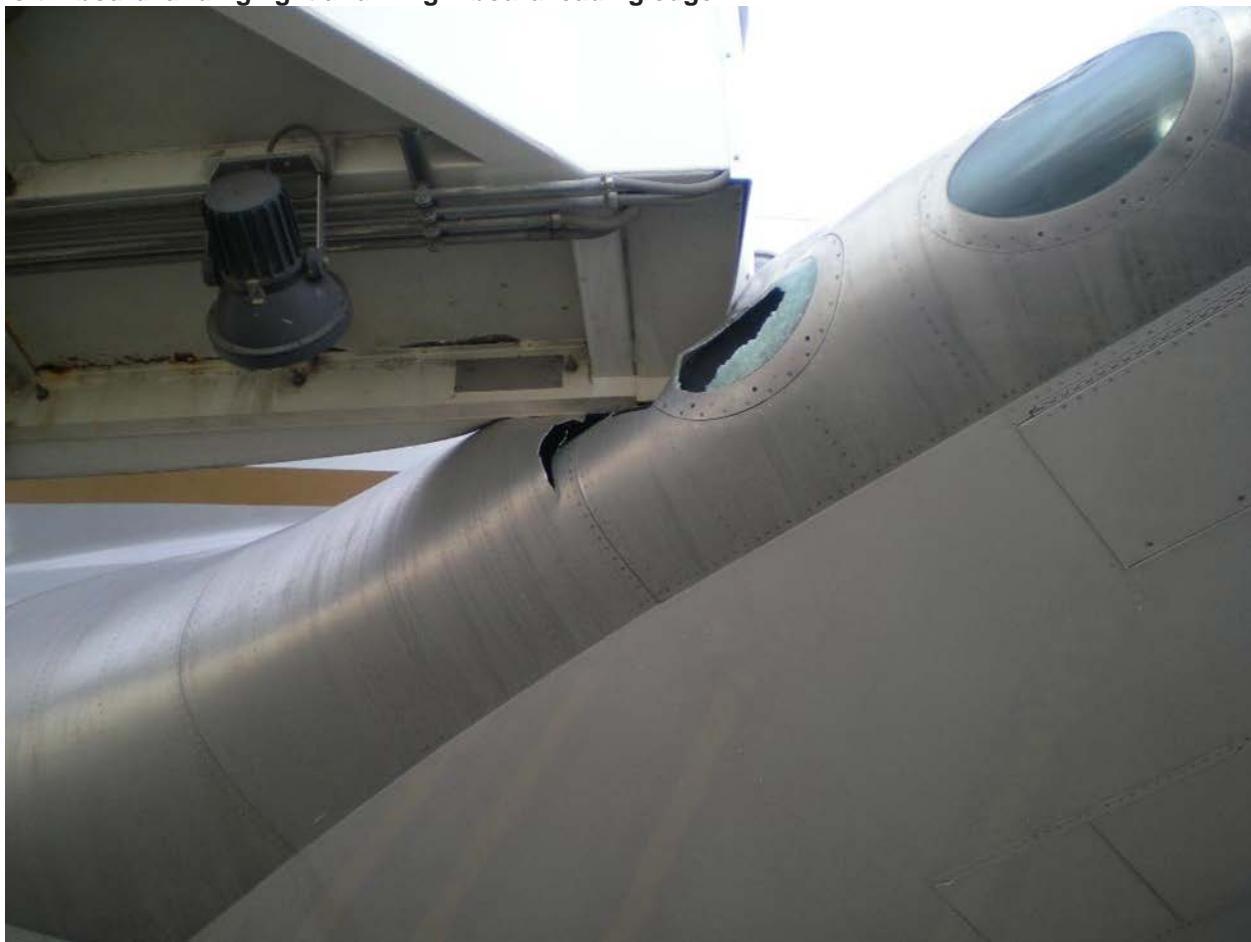
Recorded data showed that 4 seconds after stopping, the aircraft started to move slowly forward and the speed brakes were retracted. The flight crew were conducting the parking flow actions at that time. These included shutting down the engines. Fifteen seconds later, the left wing inboard leading edge contacted the aerobridge (Figure 1). The aircraft had moved forward about 12 m.

The aircraft sustained minor damage at the left wing inboard leading edge.

Figure 1: Underside view of aircraft's impact with the aerobridge, showing damage to the left inboard landing light and wing inboard leading edge

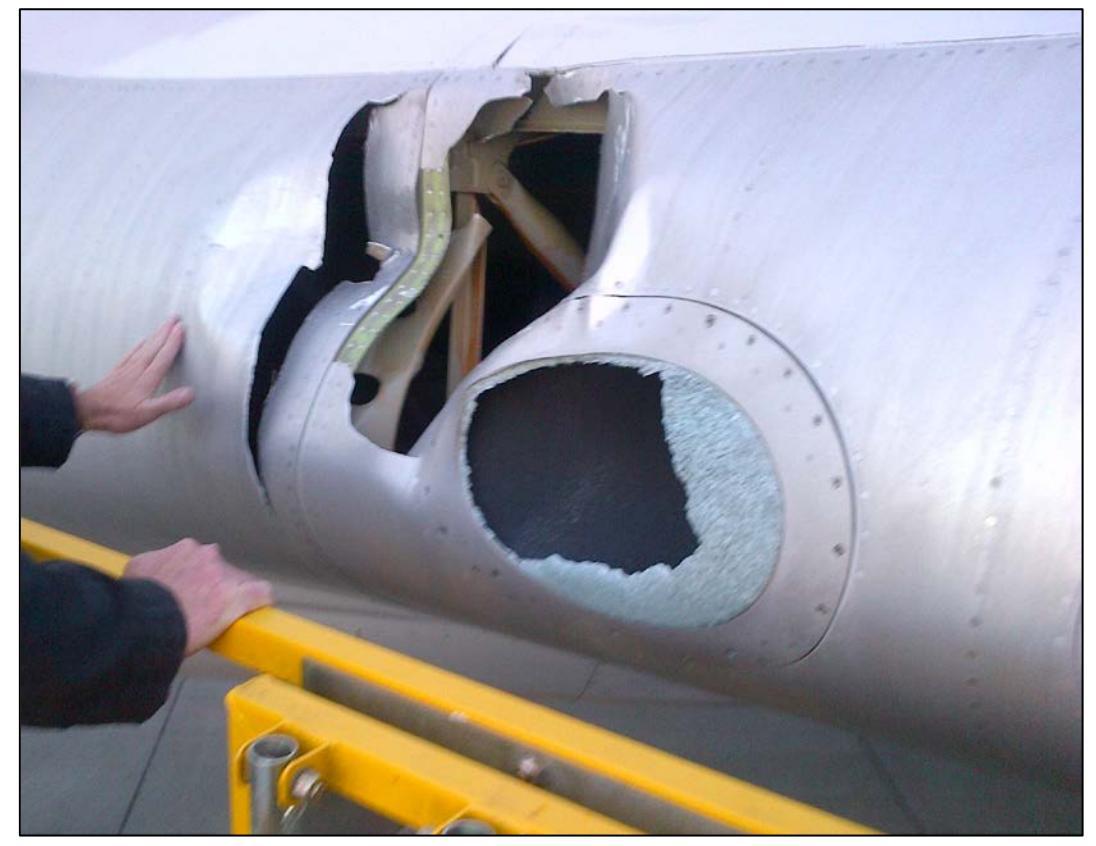
The left wing inboard leading edge was damaged by the collision with the aerobridge (Figure 4). A landing light cover was also damaged. Before the aircraft was ferried to United's home base, the leading edge and landing light covers were temporarily repaired. Permanent repairs were carried out in the United States.

Figure 4: Close up of the damage to the left wing inboard leading edge and landing light cover
