Air Accident Investigation Unit Ireland

SYNOPTIC REPORT

SERIOUS INCIDENT Airbus A320, EC-LVQ Dublin Airport

27 September 2017

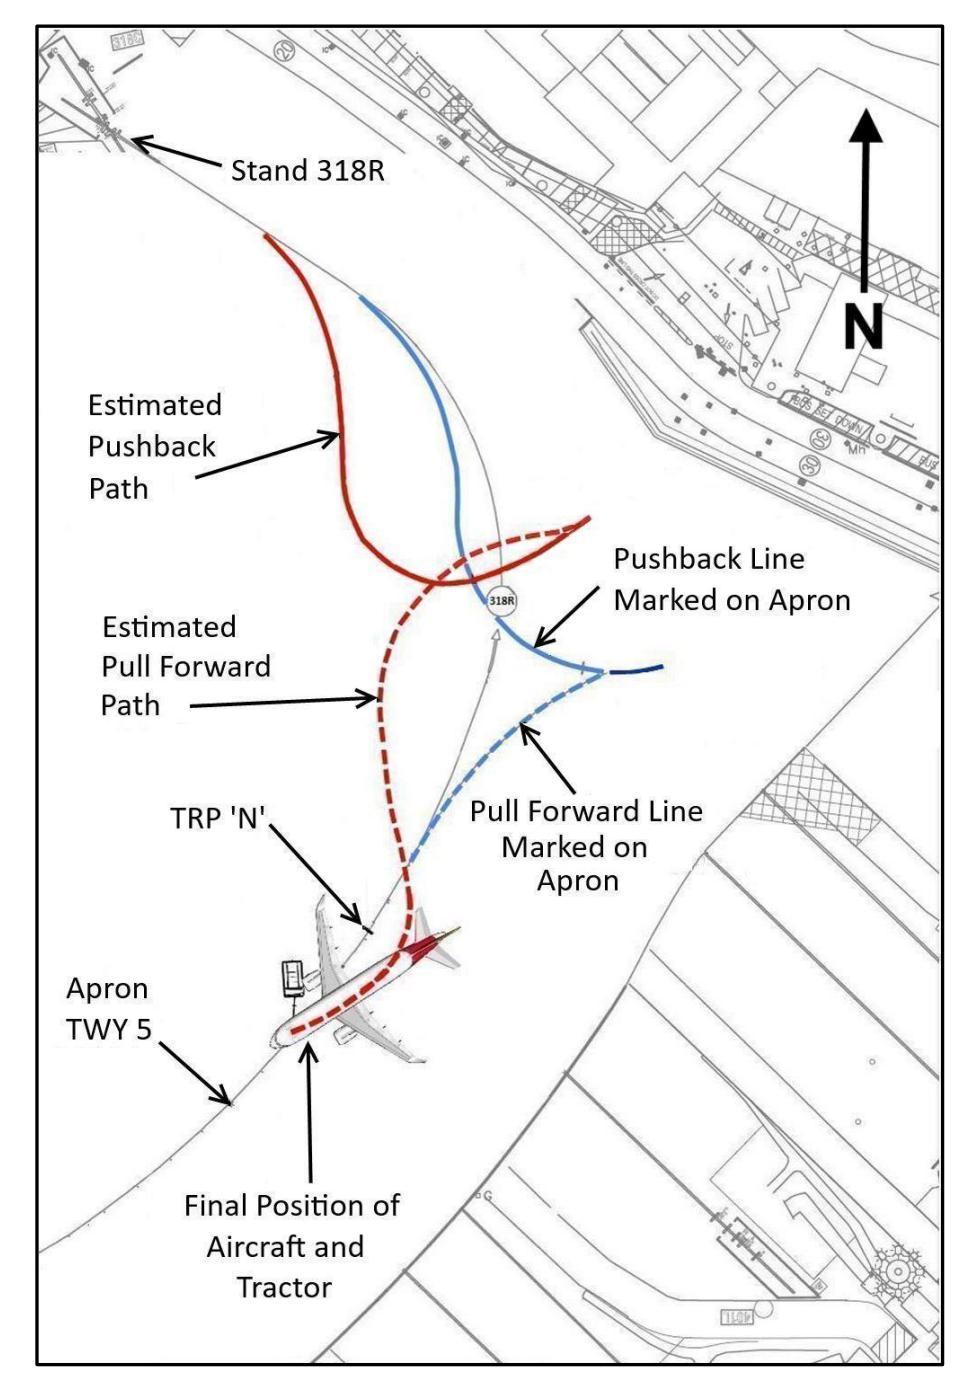
Figure No. 1: Path taken by the Aircraft as it was pushed off Stand 318R and pulled towards TRP 'N'

Airport Authority ramp markings and guidance material indicate the pushback path to be taken by A320 aircraft when manoeuvring from stand 318R. Training material provided by the ground handling company indicate that ramp personnel are shown the different ramp markings to be found and their meaning. Although the pushback and pull forward paths did not follow the marked apron guidance line for A320 aircraft, the Investigation is of the opinion that the ground manoeuvring limitations for the aircraft were not exceeded, but did result in more acute turning angles by the tractor as it approached Apron Taxiway 5.

Swissport Ground Handling should ensure that all ground crews are made aware of, and follow, the correct manoeuvring procedures at Dublin Airport. (IRLD2018008).

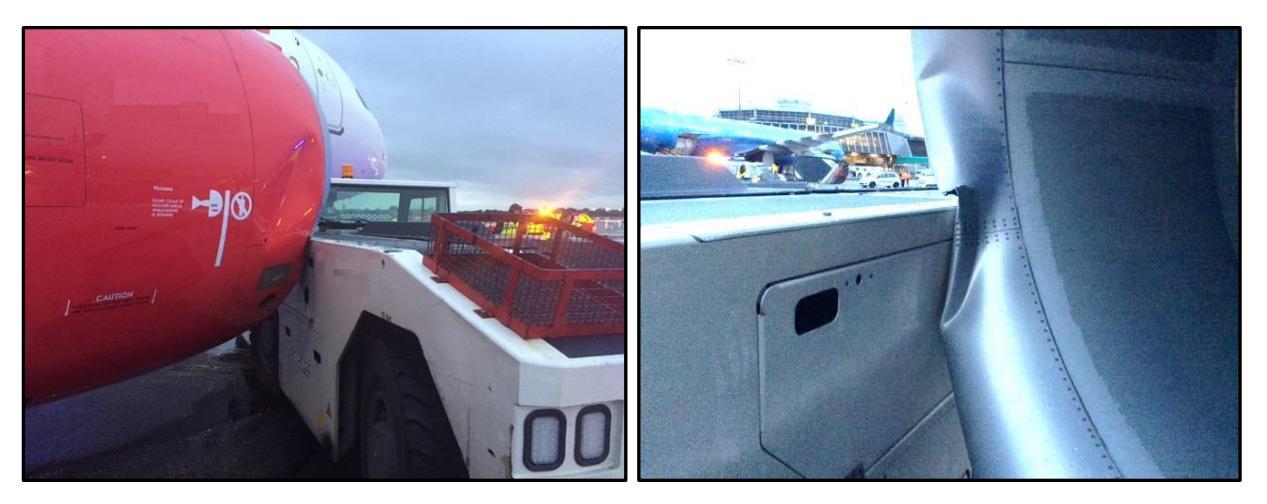
The aircraft's starboard engine cowling sustained damage (**Photo Nos. 1 & 2**). No other damage to the aircraft or engines was reported.

Photo Nos. 1 & 2: Damage to starboard engine cowling

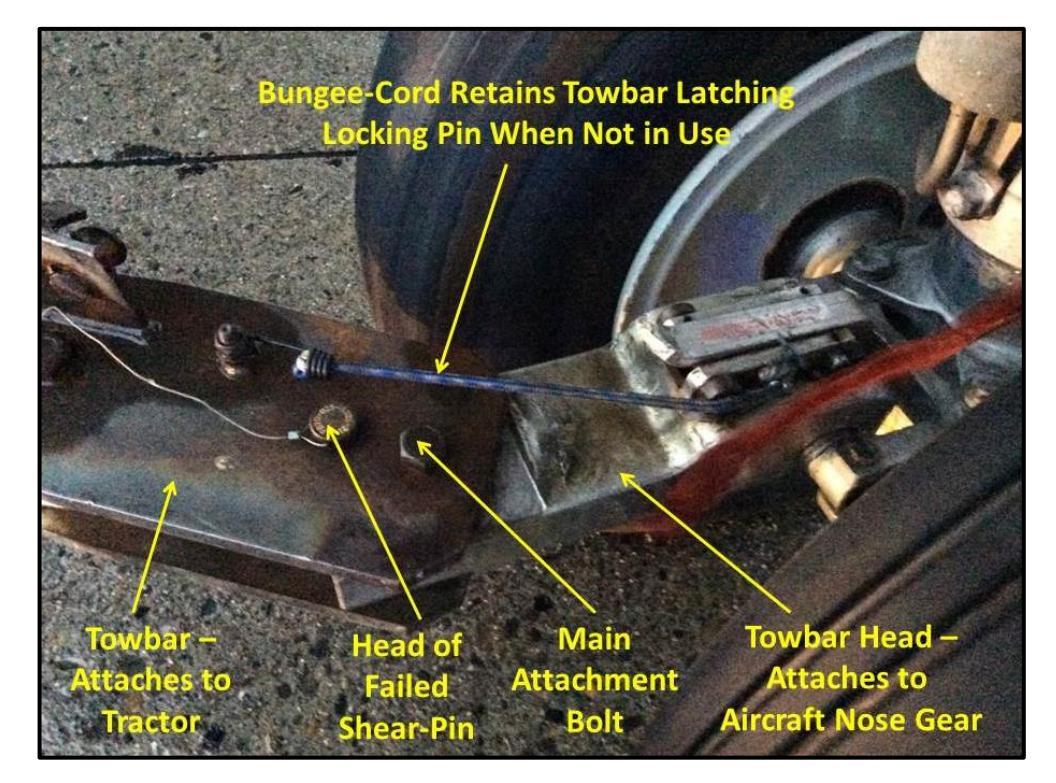
The shear-pin⁷ in the head of the towbar was found to have sheared, leaving just the head of the pin in place (**Photo No. 3**).

Photo No. 3: Towbar and towbar head as found following the occurrence

In the case of the subject towbar, there is a main (non-shearing) bolt that attaches the towbar to the towbar head through a slot in the towbar head. A shear-pin then locks the towbar in line with the towbar head (**Appendix A**). The Investigation is of the opinion that it would not have been possible to perform the initial pushback manoeuvre with a sheared pin, and that the pin therefore sheared during the latter stages of the pull forward manoeuvre.

Failure of the towbar shear-pin during a pull forward manoeuvre.

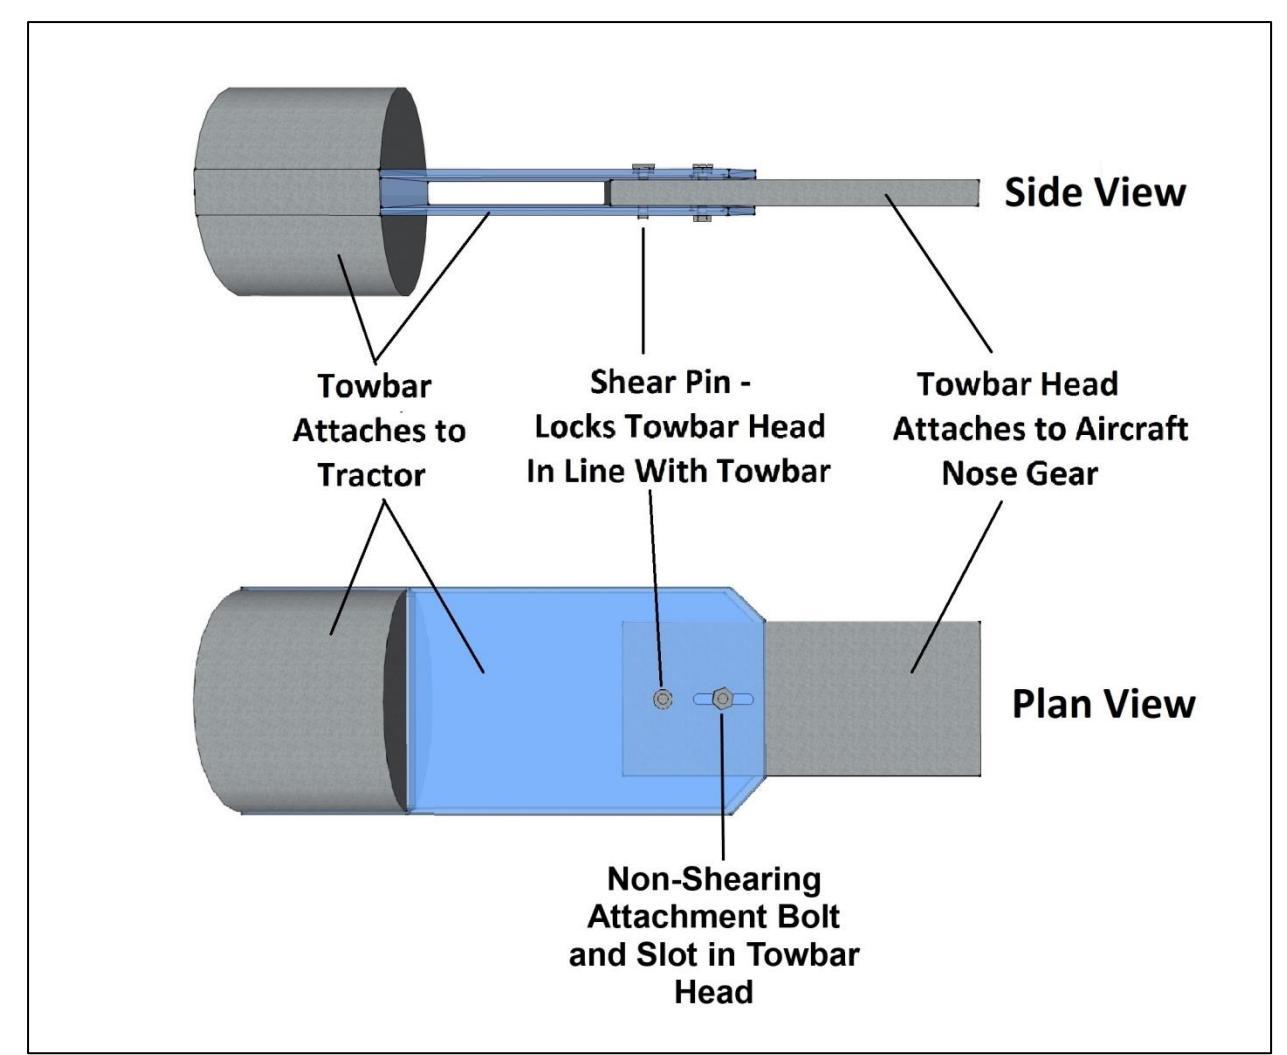
Figure 1: Towbar and towbar head in line as per normal operation

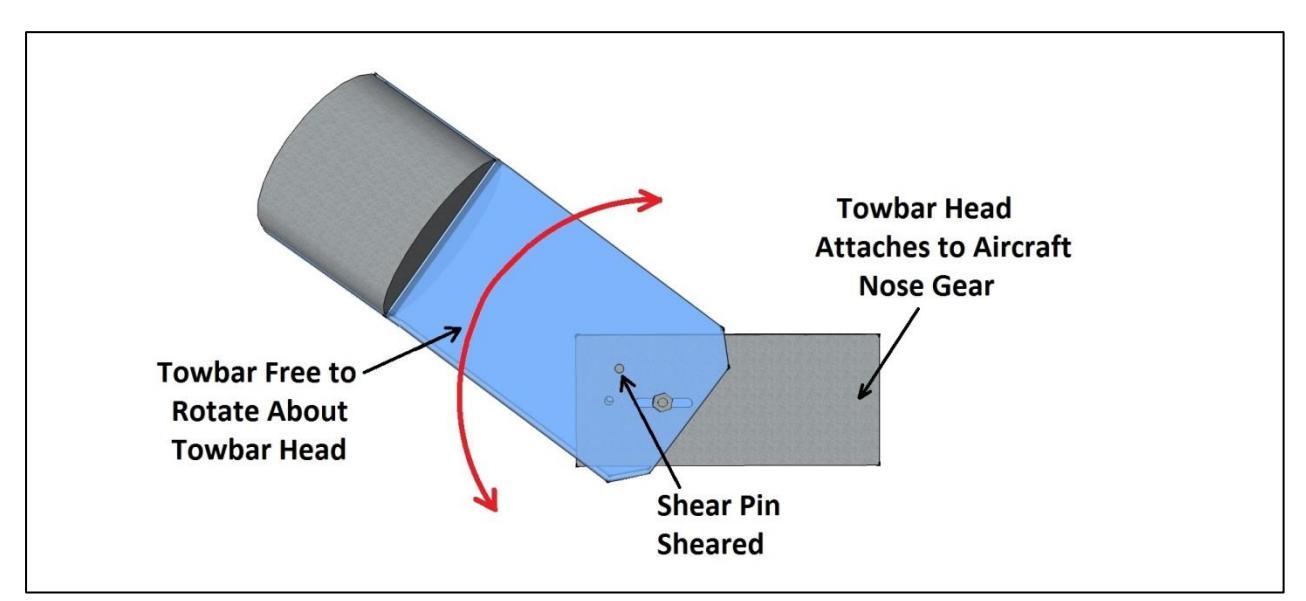
Figure 2: Towbar and towbar head out of line due shear-pin failure
