# Collision with aerobridge involving Boeing 747-422, N119UA

Melbourne Airport, Victoria | 22 April 2013

Aviation Occurrence Investigation AO-2013-075 Final – 7 July 2016

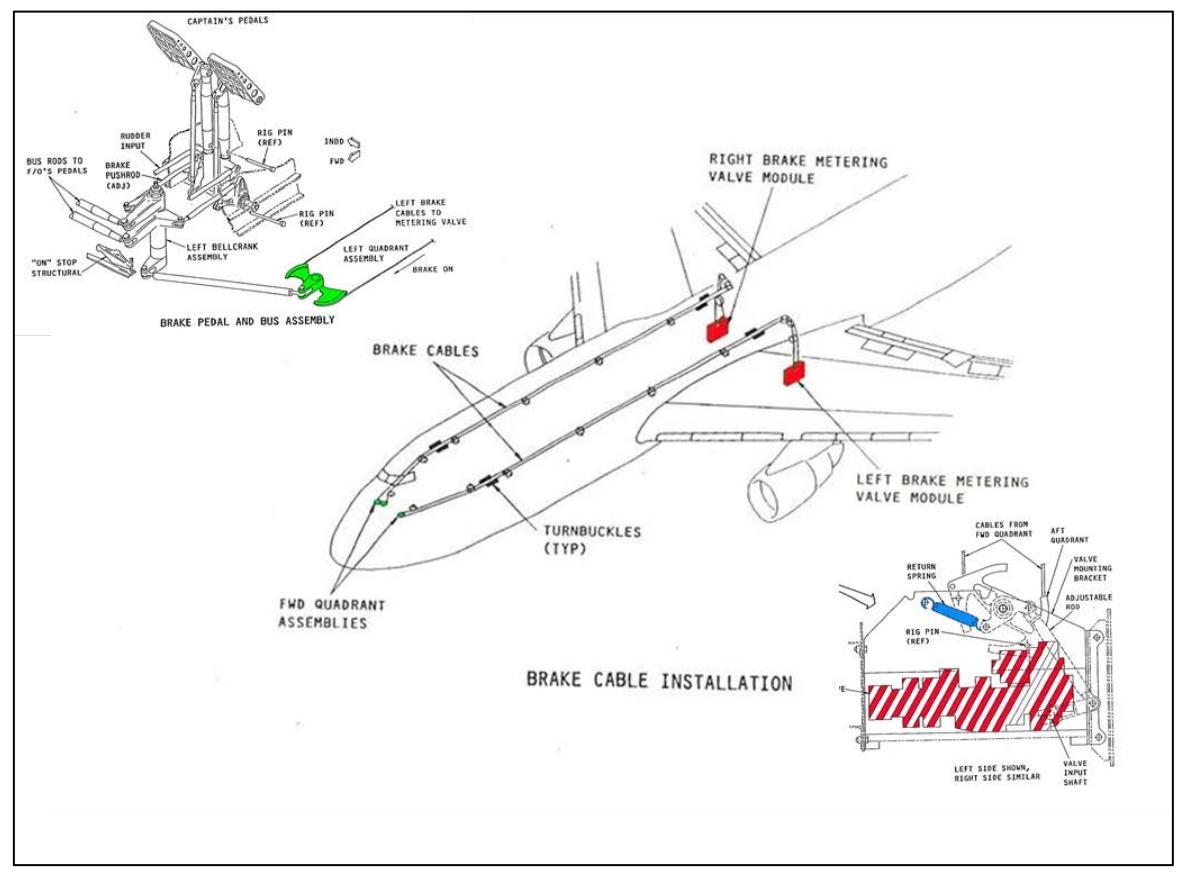
Activating the brakes allows the brake metering valves to supply hydraulic pressure to the wheel brakes. Removing the force from the tops of the rudder pedals returns the metering valves to neutral through the action of the return springs (Figure 2). This relieves the hydraulic pressure to the wheel brakes.

Figure 2: Boeing B747-400 wheel brake system schematic. The upper-left image shows the mechanical interconnection between depressing the top of the rudder pedal and the movement of the brake cables, the centre image the wheel brake cables' layout and the lower-right image a hydraulic metering valve (the return spring is shown in blue)

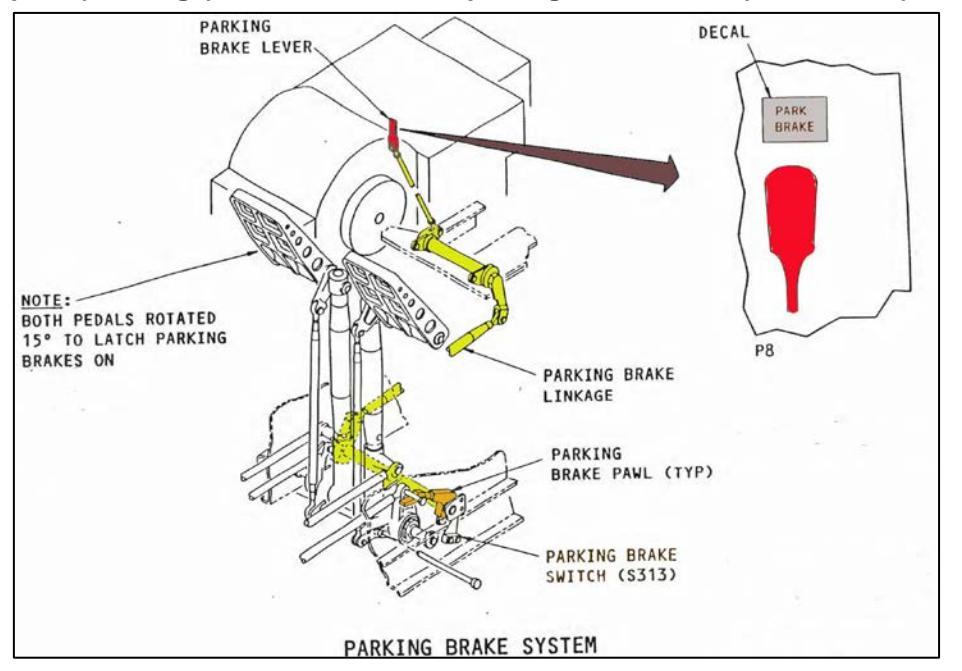
The parking brake system is controlled using a parking brake lever situated on the left (captain's) side of the flight deck centre console. The lever is connected mechanically to a pawl at the rudder pedals (Figure 3). Once the tops of either pilot's rudder pedals are pressed to at least 15°, the lever can be raised allowing engagement of the pawl. The pawl retains the rudder pedals in this position and the metering valves allow continued supply of hydraulic pressure to the brakes.

The pawls are themselves held in position by the force applied by the metering valve return springs. Applying additional force to the tops of the rudder pedals results in the pawls moving away from the 'locked' position, releasing the wheel brakes.

Figure 3: Boeing B747-400 Parking brake system, showing the mechanical interconnection (in yellow) between the parking brake lever (in red) and the parking brake pawl (in orange) and the location of parking brake switch (switch S313)
